Upgrading the Sylvenstein reservoir sealing and inspection system

The Sylvenstein reservoir was brought up to date between 2011 and 2015 after more than 50 years in operation by adding a diaphragm wall to the existing dam and subsoil, as well as a new measurement system for seepage. These additional upgrades are also considered preventative measures against possible impacts of climate change, as the magnitude and frequency of recent flood events imply an expected larger stress on the dam in the future. With a total cost of about EUR 23 million, construction work was co-financed by the European Fund for Regional Development.

Tobias Lang and Gregor Overhoff

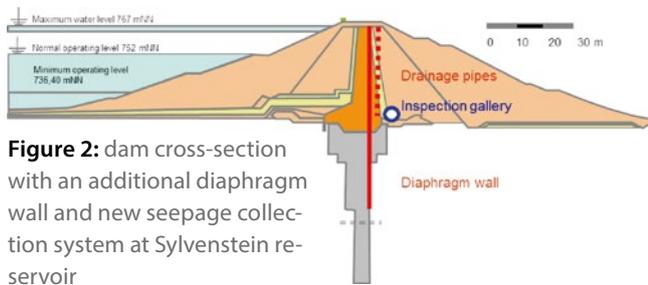
Figure 2: dam cross-section with an additional diaphragm wall and new seepage collection system at Sylvenstein reservoir

In 2014, the Porr company created 54 drainage piles with a depth of about 41 m between the diaphragm wall and the inspection gallery (Figure 2) to withdraw and pinpoint the location of potential seepage. A centred drainage pipe withdraws potential leakage water, which collects in the base of the pile from where it is emptied in the new inspection gallery and measured.

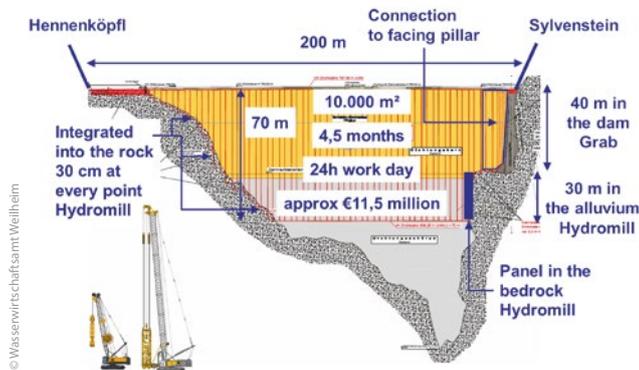
Installation of a diaphragm wall up to 70 m deep in the dam core. This wall goes about 25 m deep below the level of the dam foundation into the original ground of the Isar River (Figure 4). The diaphragm wall was created as a two-phase wall in 2012 using cutting and large gripper devices from Bauer Spezialtiefbau.

Figure 4: Diagram showing areas where the grab and hydromill were used and performance data during creation of the diaphragm wall by Bauer Spezialtiefbau GmbH

A diaphragm wall grab and a hydromill were deployed at the same time, so that the short construction time planned for the 10,000 m² diaphragm wall could stay on track (Figure 4). The space required for the work and crossover traffic for large machinery was created by widening the dam crest by 4 m with a downstream angular retaining wall. This additional space has been used as another strip of parking spaces since the project's completion. Machinery reconfigurations (assembling the cutter along the direction of travel of the support frame (Figure 5) saved the need for extra work space. A mixing unit was set up at the B 307 alongside the dam crest to create and prepare the bentonite slurry.

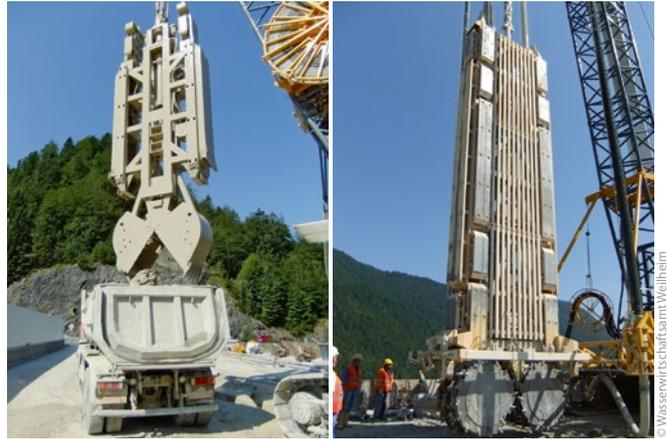
Figure 5: The Bauer Spezialtiefbau diaphragm wall grab and hydromill cutter in operation

finied compressive strength of 21-96 MPa) were created using the hydromill fitted with pin chisels (Figure 5). This division of work meant that material excavated by the grab did not have to be segregated by the separating plant, and the hydromill's higher performance could be used optimally at greater depth.

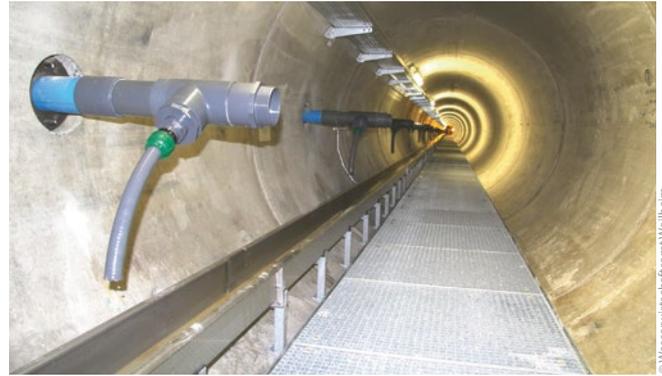
Figure 9: View of the inspection gallery with the seepage collection system and interior fitting

The interior fitting of the inspection gallery with measuring technology took place in the winter of 2014/2015 (**Figure 9**). The measuring technology allows for constant, section-by-section monitoring of seepage amounts throughout the entire dam. Therefore, the stipulations of DIN 19,700 Part 11 – Dams for direct, section-by-section measuring of seepage amounts are met. Each individual drainage pile can also be irrigated individually using a system of shafts and hoses and thus checked for functionality. A pressure bulkhead is installed at the end of the inspection gallery to be of the safe side, designed to handle 40 m water pressure.
